In this test we want to investigate the lifespan of our CFROBOT7 in $\pm 180^\circ/\text{m}$ chain application.

Series / No: CFROBOT7

e-chain® type: TRC.70.110.0

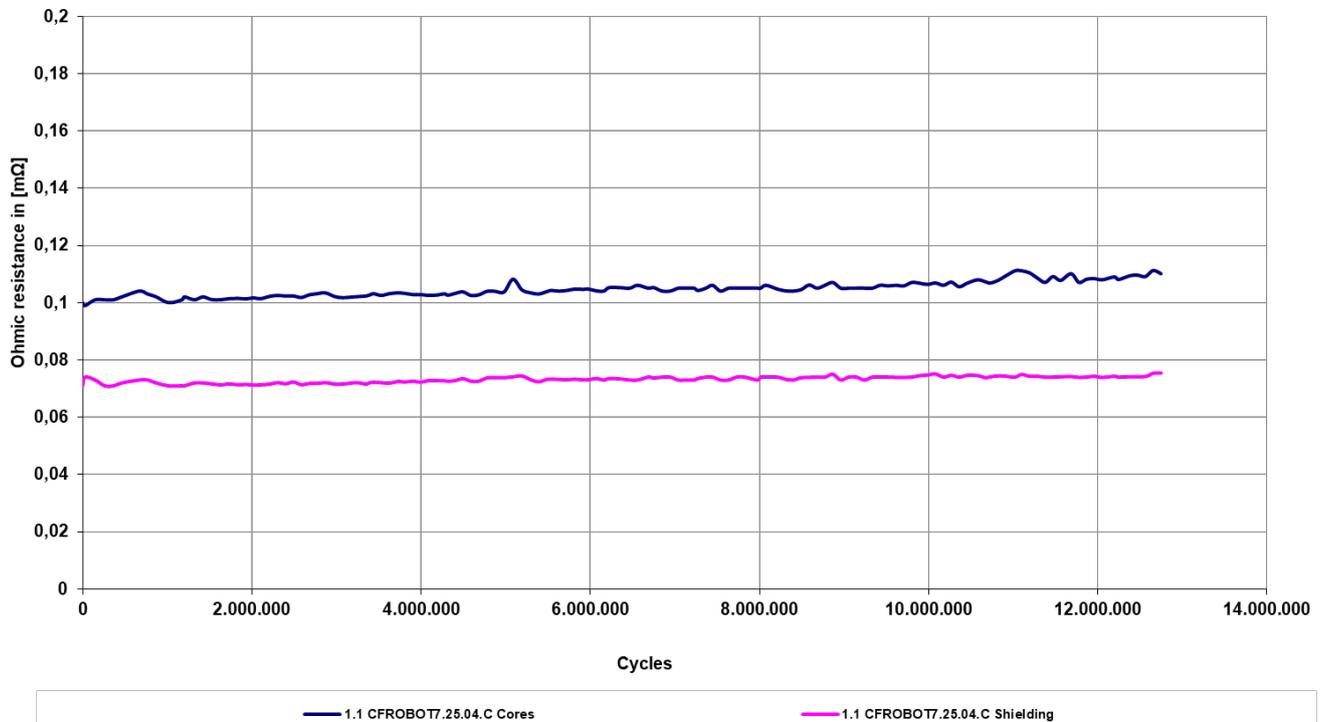
Trend of the ohmic resistances

At the 08.07.2013 we demounted the cable 1.1 after 12.750.335 cycles, to check the condition of the cable elements.

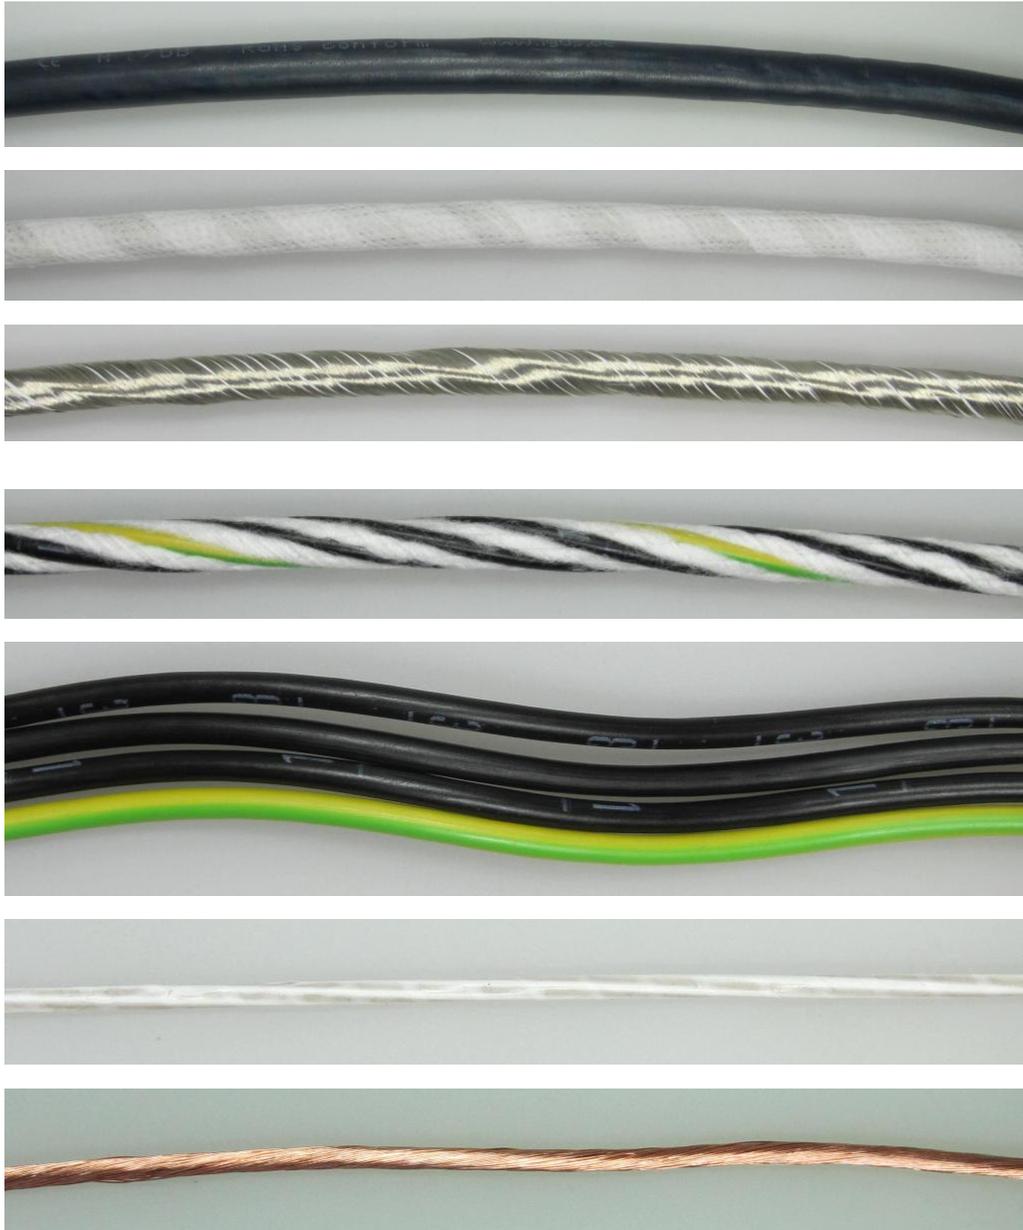
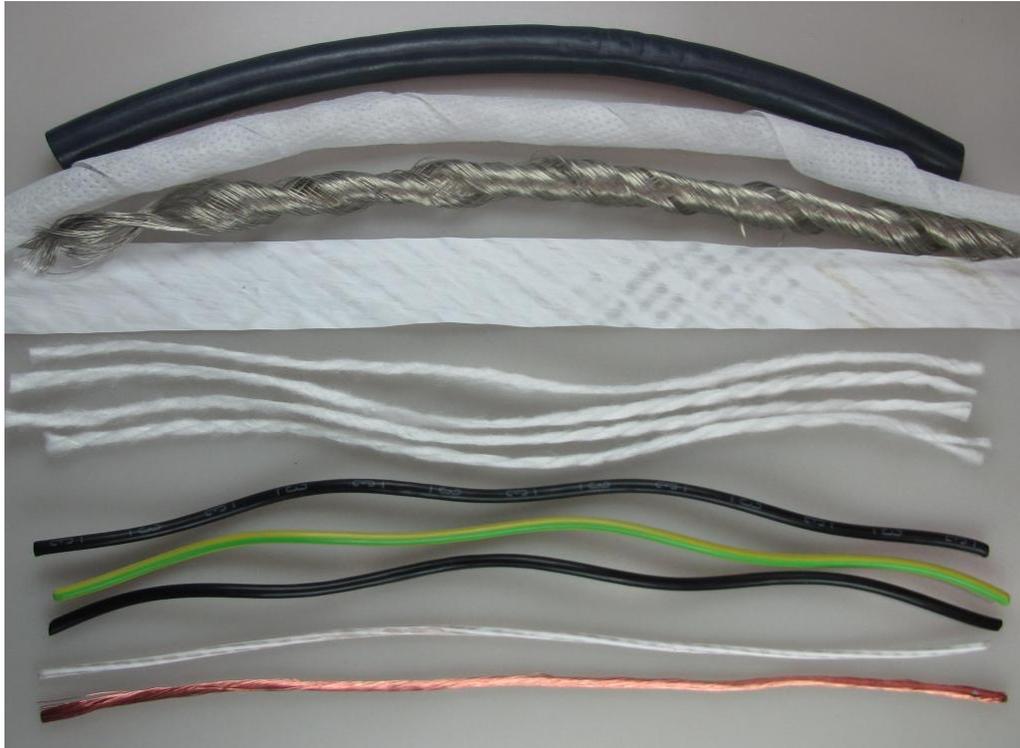
The condition of the cable no. 1.1 (CFROBOT7.25.04.C) after 12.750.335 cycles

Cycles	12.750.335
Condition outer jacket	O.K.
Condition overall shielding	O.K.
Condition banding	O.K.
Condition filler	O.K.
Condition center element	O.K.
Condition core insulation	O.K.
Condition conductor	O.K.
